FROM THE FIELD

The Problem:

A power plant located in Texas was experiencing numerous problems in their #3 Boiler. The furnace of the #3 Boiler is comprised of approximately 24,000 linear feet of 2.5" OD, 0.203" and 0.300" nominal wall thickness smooth bore carbon steel water wall tubing. The unit was experiencing tube failures due to I.D. pitting, corrosion cells, and hydrogen damage. Many destructive samples verified both the location and severity of several defects initially found with the *Low Frequency Electromagnetic Technique (LFET)* developed by TesTex, Inc.

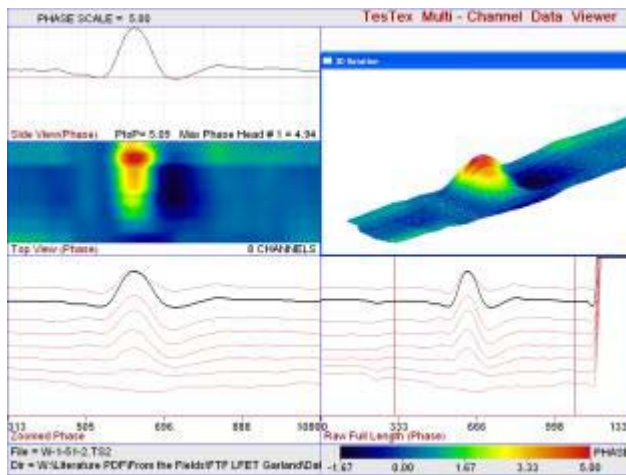
Flaw Indication found on the left side of tube #51 collected from the North Wall

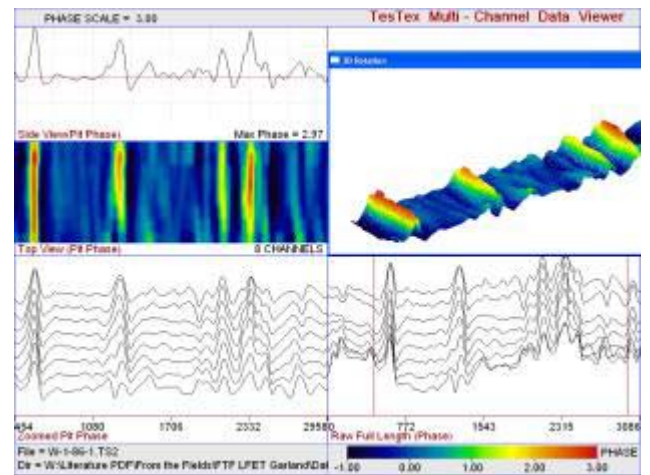
Several Flaw Indications found along tube #86 in different locations collected from the North Wall
