STATE OF THE ART PRODUCTS AND SERVICES
FOR NON-DESTRUCTIVE TESTING

FROM THE FIELD

Problem:

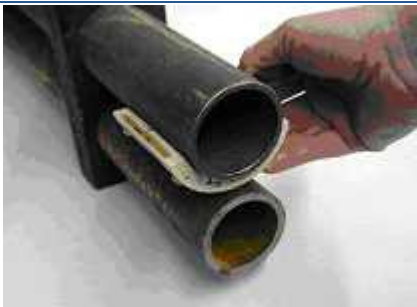
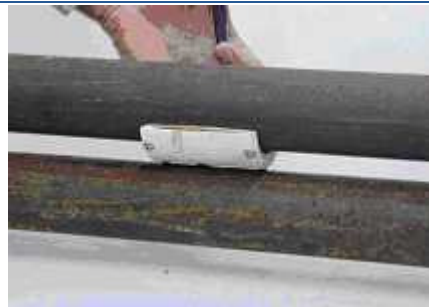
These pictures show the LFET Low Profile Scanner and the geometry of the reheater tubes.

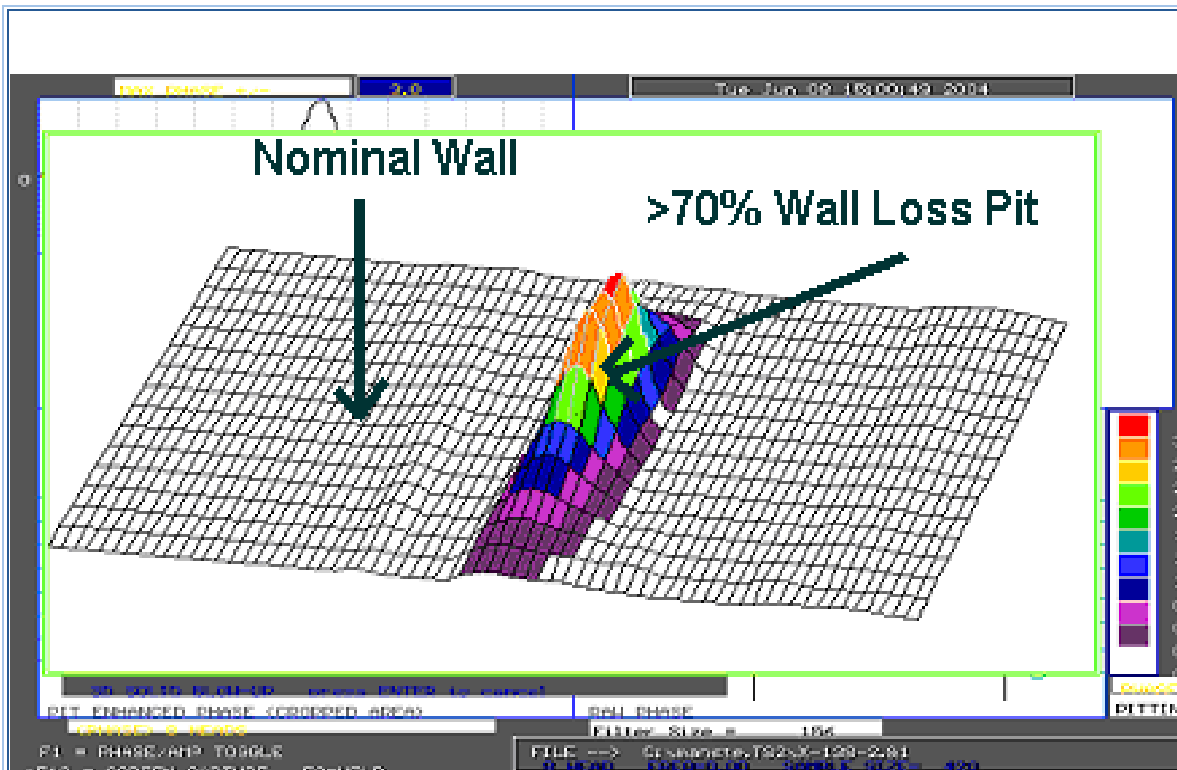
A total of 58 tubes were identified with pits ranging from 20-30% wall loss to >70% wall loss. A few of the tubes had several pits along a 3' area. A tube identified as having >70% wall loss was cut out. This cut-out contained a pit with less than .054" wall remaining or >70% wall loss.

This waveform shows a pit with >70% wall loss.

Fifty-eight flaws in the plant's Unit #3 Reheater were located and repaired with dutchmen or pad welds. Thus, 58 potential forced outages were avoided. According to plant personnel, it takes a minimum of 72 hours to bring the boiler down and repair a tube leak on the 700mw unit.
