STATE OF THE ART PRODUCTS AND SERVICES
FOR NON-DESTRUCTIVE TESTING

FROM THE FIELD

Problem:

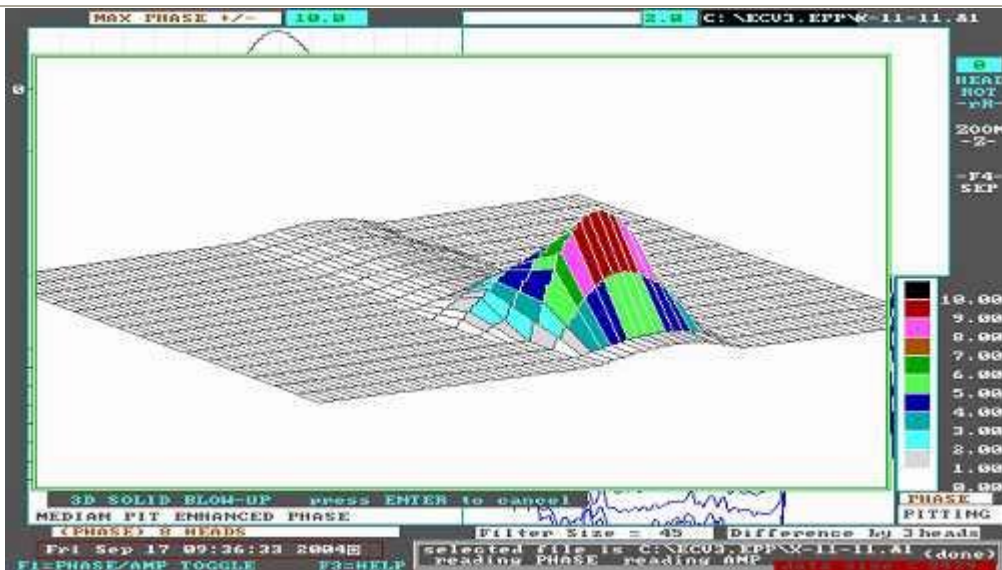
A total of 7 tubes were identified with pitting. The most severe indication exhibited >45% wall loss. The other 6 tubes exhibited between 20-25% wall loss. The tube identified as having >45% wall loss was proved-up using a boroscope.

This waveform shows the pit exhibiting >45% wall loss based on a nominal wall thickness of .165". This isolated pit was found between the mud drum tubesheet and bend.

All 7 flaws in the generating bank cold side were scheduled for plugging. This assessment of the cold side of the generating bank has minimized the potential need for a forced outage.

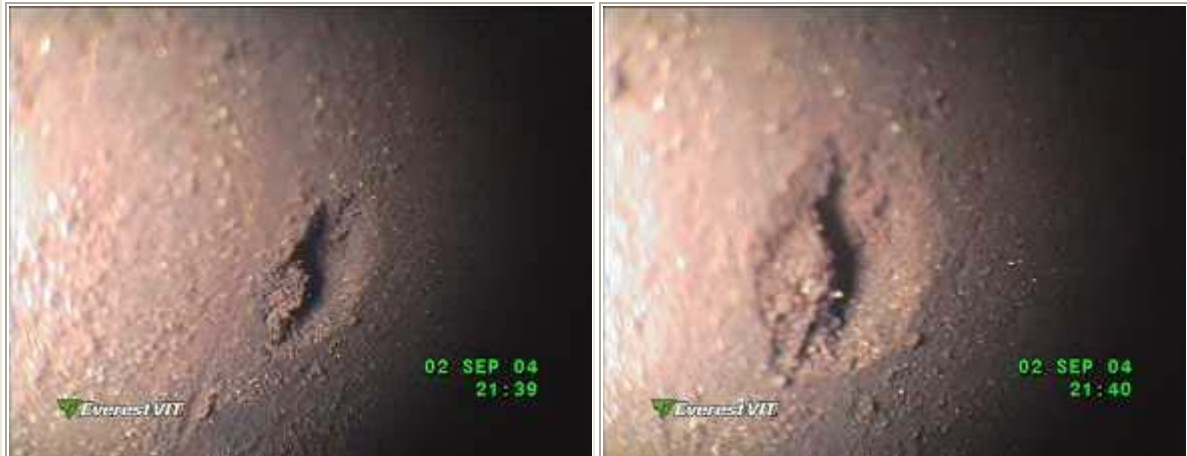
These pictures are the boroscope still shots, showing the isolated pit that was found exhibiting >45% wall loss using the [Eagle 2000 Plus Multichannel NDT System](#).
