AN INSIGHT INTO INVESTIGATION OF REPETITIVE BOILER TUBE FAILURES

Kesavan. Manikantan, Manager
Nilesh S. Rapte, General Manager,
N. K. Keshava Prasanna, Vice President,
Central Engineering Services (Mechanical)
Reliance Industries Limited, Patalganga.

There was quick succession of failures of furnace water wall tubes in 16 years old Borsig make closed circuit Boilers in a short span of 6 months. Advance inspection techniques, maintenance practices were used to get the boilers on stream at the earliest possible time.

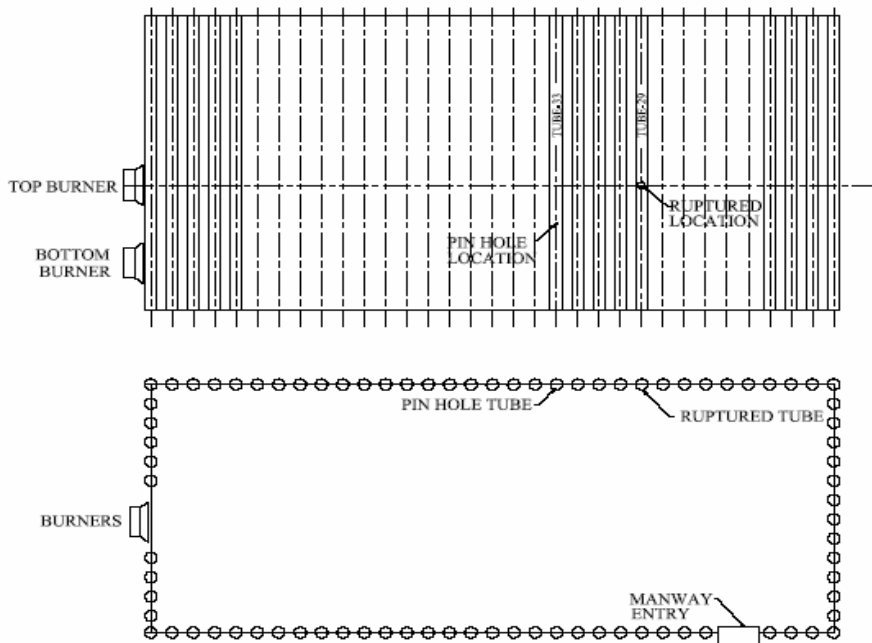
Figure 2: Furnace Chamber Layout showing location of failed tubes of side wall.

The boiler had tripped on high furnace pressure caused due to water leak from the riser furnace water wall tube. On opening the boiler furnace chamber, the chamber was found filled with water. Furnace water wall tube facing the fire side of the chamber was found leaking. Two of the tubes were found ruptured opened up and two tubes were found with pinhole leak. The location of the rupture / pin holes is as shown in the layout of the furnace chamber (refer Figure 2).

Only the Side wall tubes of the furnace chamber were found leaking. No external corrosion / oxidation or bulging of tubes was observed.

Refer Figure 2 for the layout of furnace chamber showing locations of leaky tubes.

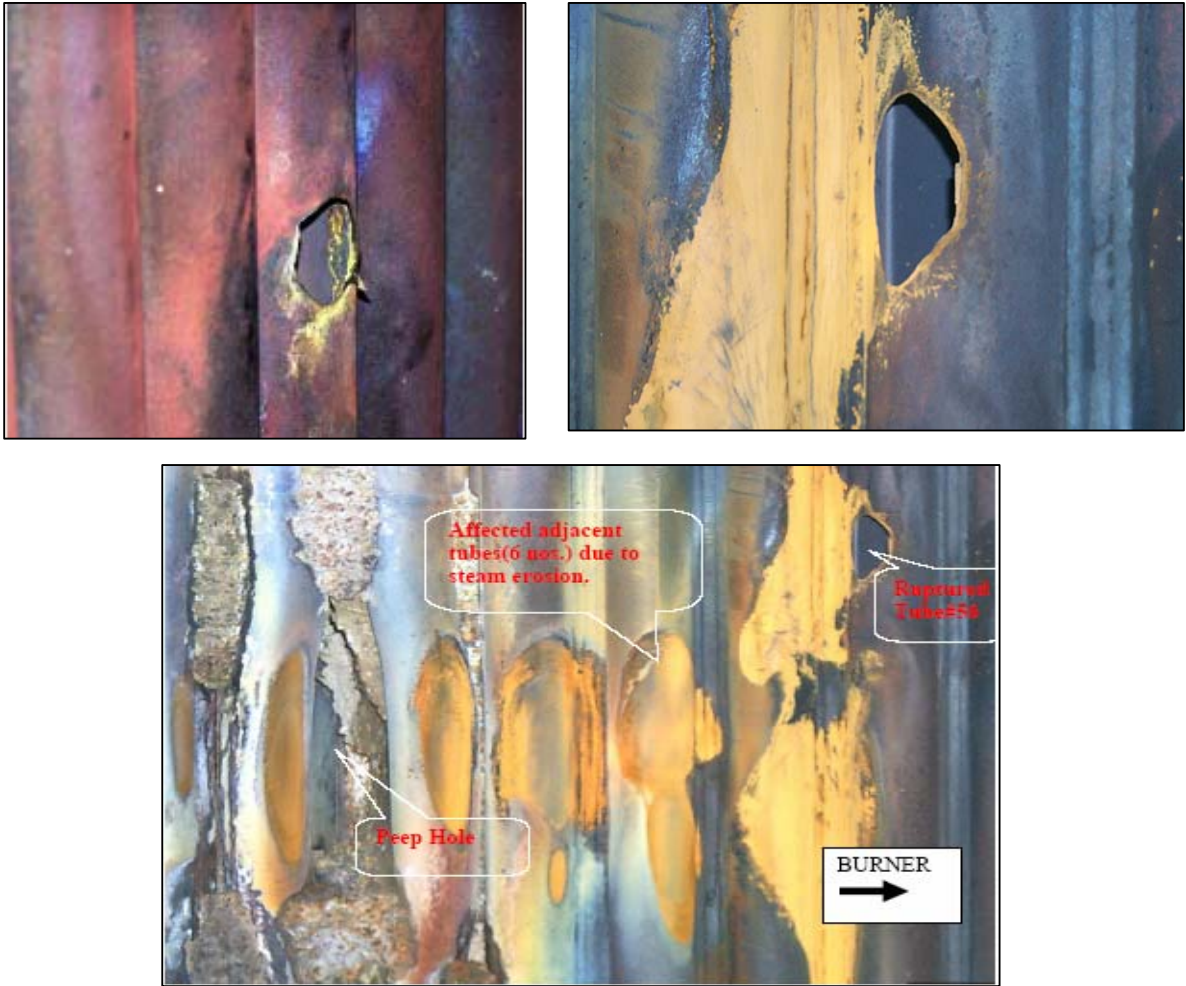
Figure 3: Photographs of ruptured Furnace water wall tubes.

The leaky tubes, in the mid section of side furnace wall were found with typical ruptured hole of about 1.5” diameter. The ruptured hole was found to be of irregular shape. Refer Figure 3.

The hole was located at about 10 feet above the Furnace chamber floor level. The hole was found to be in match line of bottom side of muffle block of top burner.

Internal inspection of the tube was carried out using fibroscope through the ruptured hole. Internal surface of the tube exactly opposite the rupture hole was found covered with a black layer of magnetite. Grooving and roughness on internal surface of the tube was observed above and below the ruptured hole along the axis of the tube. Circumferentially no grooving or surface roughness observed inside the tube around the ruptured hole.

External surface of the tubes with ruptured hole was found free of corrosion or pitting. No evident bulging observed in the tubes.

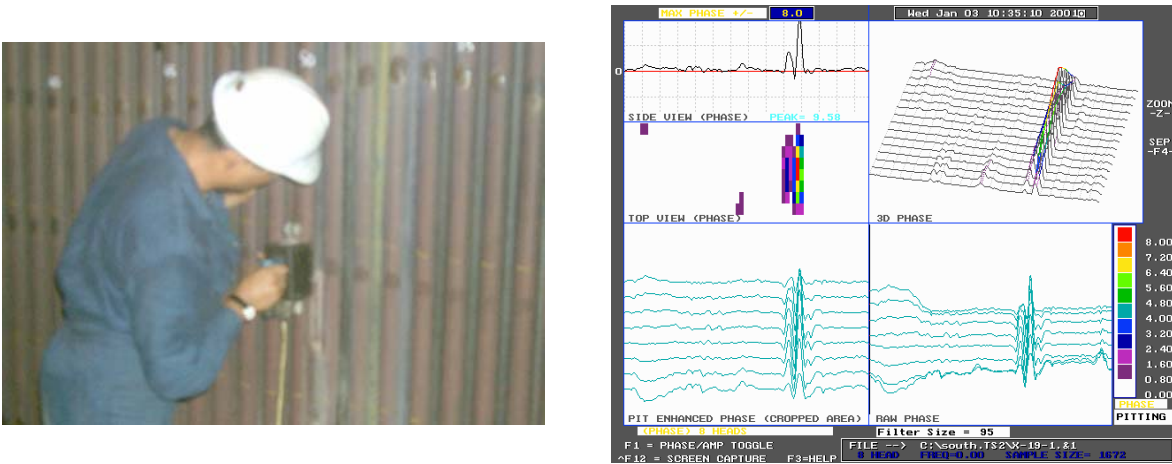
Figure 4: LFET testing of Furnace Water wall tubes and typical waveform display of LFET at internally corroded tube.

The OD of the furnace water wall tubes facing the furnace chamber (fire side) were checked by LFET using probes suitable for the OD of the tubes. The areas of the tubes found with abnormality as indicated by phase change were marked and re-examined by ultrasonic flaw detection. Refer Figure 4 for LFET inspection and a typical waveform display of corroded tube.

About 9 side wall tubes of the furnace chamber were found with reduction in thickness on ID due to internal corrosion. The location of these abnormalities was found to be in the burner zone (about 150mm to 1800mm above the floor level of furnace chamber).

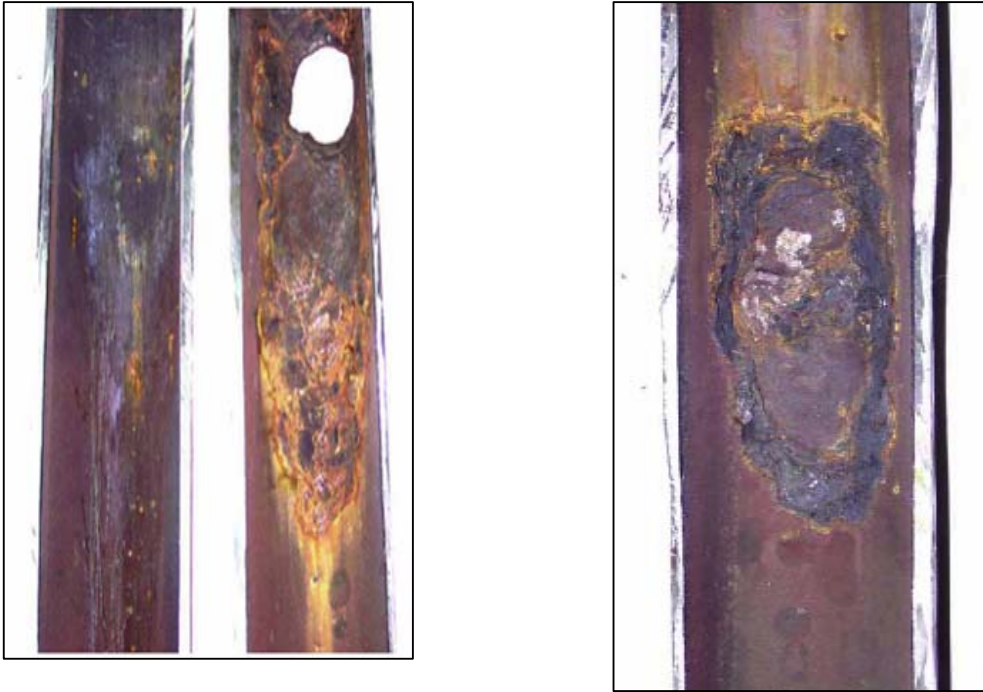
Figure 5: Internal corrosion and deposition of corrosion product inside the Furnace waterwall tubes.

At the locations where reduction in thickness was observed, internally the tubes were found corroded with burnt corrosion product around the thinned down locations. Refer Figure 5.

The corroded locations were observed only in the section of the tubes facing the furnace chamber. No pitting or corrosion observed on the internal surface of tubes away from furnace chamber (rear side of the tubes)

Internal surface of the tubes facing the furnace chamber were also found with reddish coloration and localized bubbling / nucleating marks were also observed.

The internal surface of cut out tubes facing away from the furnace chamber (rear side) was found uniformly covered with dull black magnetite scales. No bubbling or nucleating marks observed in these sections of the tubes.

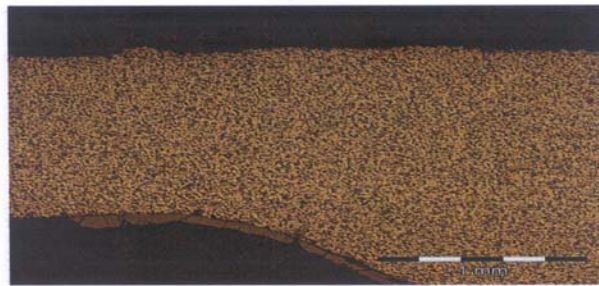
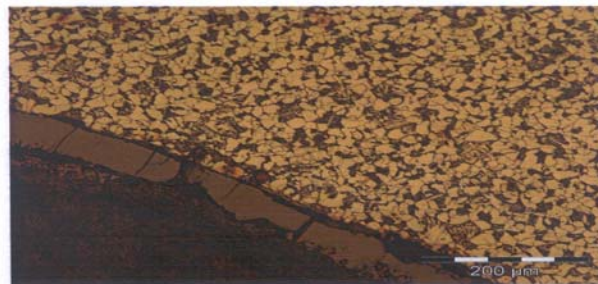
Figure 6: Microstructure across the thickness of tube showing uniform distribution of ferrite – perlite structure.

Microstructure across the thickness of the ruptured tube indicates ferrite – pearlite structure without any grain growth or grain boundary separation. The amount of pearlite in the inner edge (water side), outer edge (fire side) and centre of the tube sample was found to be uniform. There were no signs of decarburization in the microstructure. Refer Figure 6.
