STATE OF THE ART PRODUCTS AND SERVICES
FOR NON-DESTRUCTIVE TESTING

FROM THE FIELD

Problem:

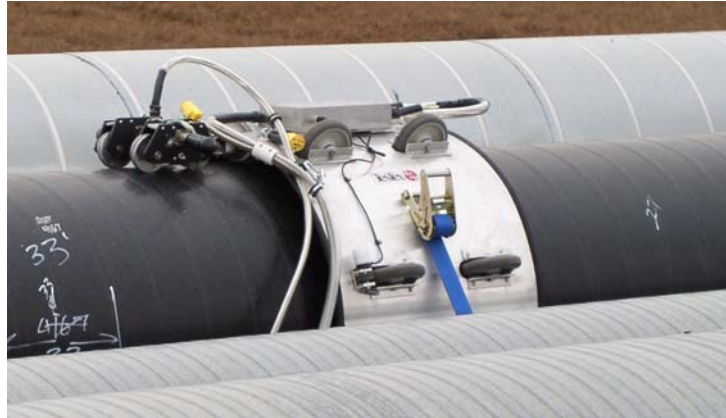
Figure 1: This photo shows the top half of the Line Cat rig and the magnetic-wheeled motor system.

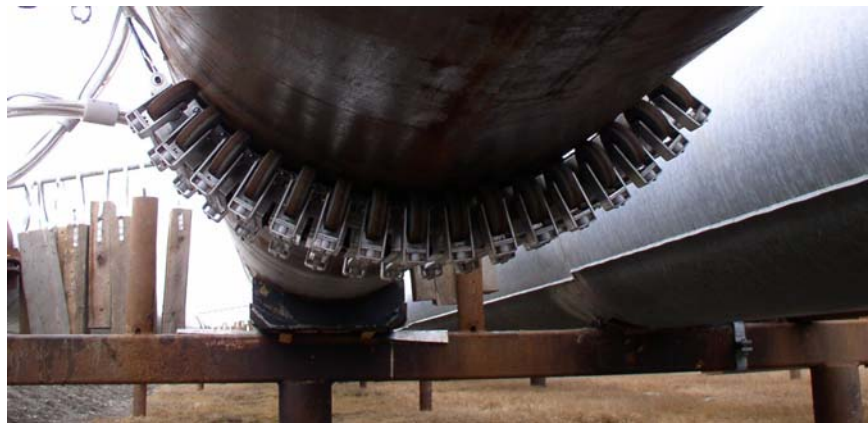
Figure 2: This is a picture of the underside of the Line Cat scanning rig. There are (16) 2" scanner pods that, when tightened against the pipe, provide a 32" wide scanning swath. Each scanning pod has a wheel at the front and rear in the same axial direction of movement, thus providing independent suspension for each 2" LFET scanner pod.

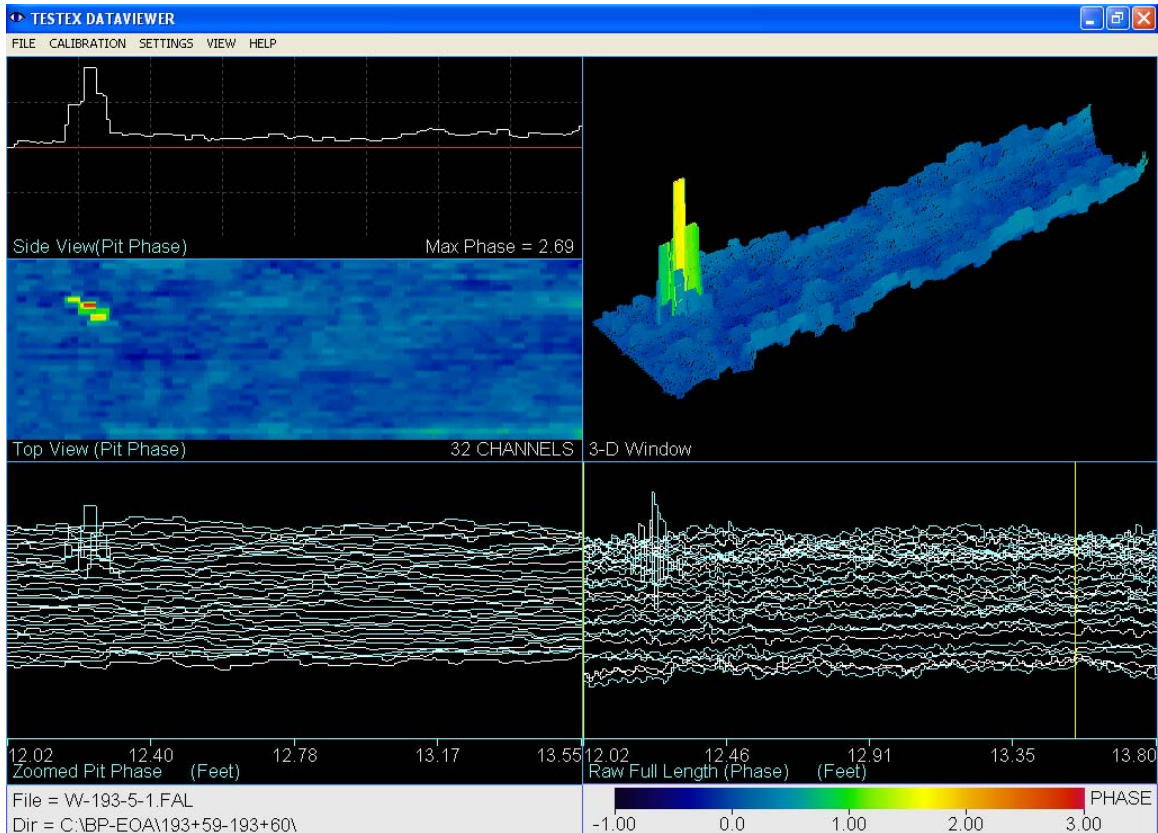
Figure 3: This figure depicts the actual display screen of an ID pit found using the Line Cat system. This waveform represents an ID pit with 0.262” wall remaining of 0.375” original wall. As the waveform shows, the pitting from MIC attack was very isolated.
