AN INSIGHT INTO INVESTIGATION OF REPETITIVE BOILER TUBE FAILURES

Kesavan. Manikantan, Manager
Nilesh S. Rapte, General Manager,
N. K. Keshava Prasanna, Vice President,
Central Engineering Services (Mechanical)
Reliance Industries Limited, Patalganga.

There was quick succession of failures of furnace water wall tubes in 16 years old Borsig make closed circuit Boilers in a short span of 6 months. Advance inspection techniques, maintenance practices were used to get the boilers on stream at the earliest possible time.

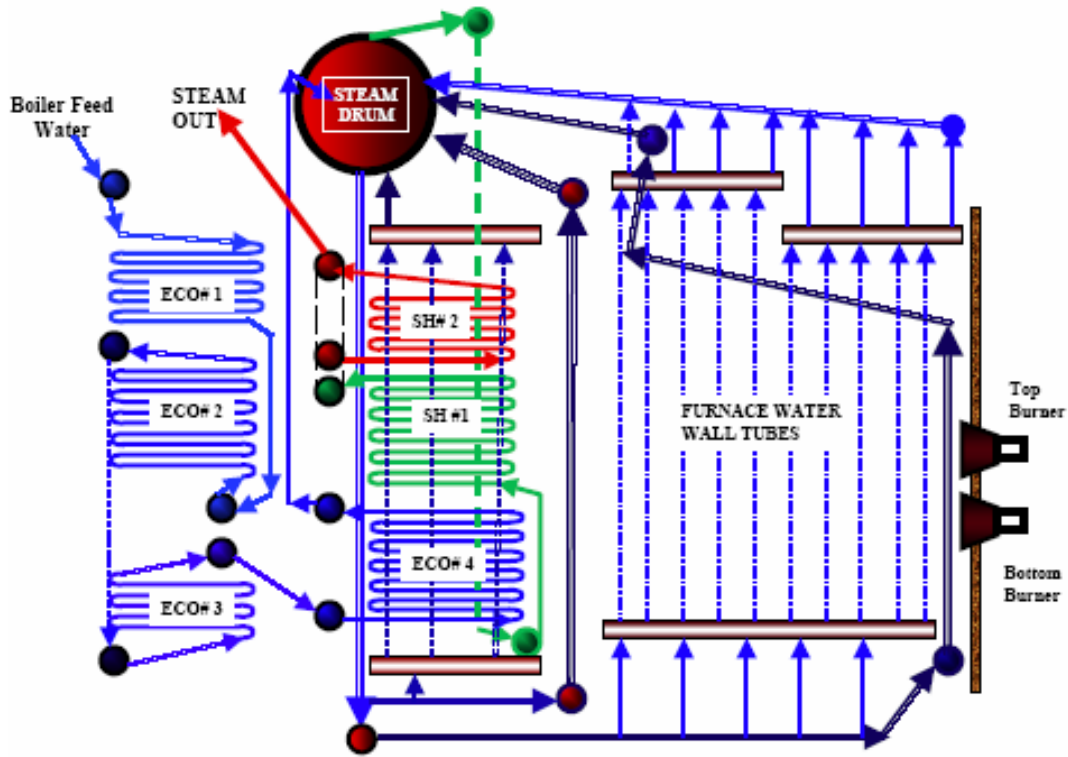
This arrangement avoids flame radiation from furnace into super heater sections. Refer Figure 1 for schematic of the boiler.

Figure 1: Schematic showing construction of Borsig Boiler.
